# Chester County Stormwater BMP Tour Guide

### BMP: Porous Pavement Parking Lot and Subsurface Recharge Bed

Site Name: East Whiteland Township Building See Tour Guidelines below prior to touring this site

#### Site 9 - East Whiteland Township Porous Pavement Parking Lot

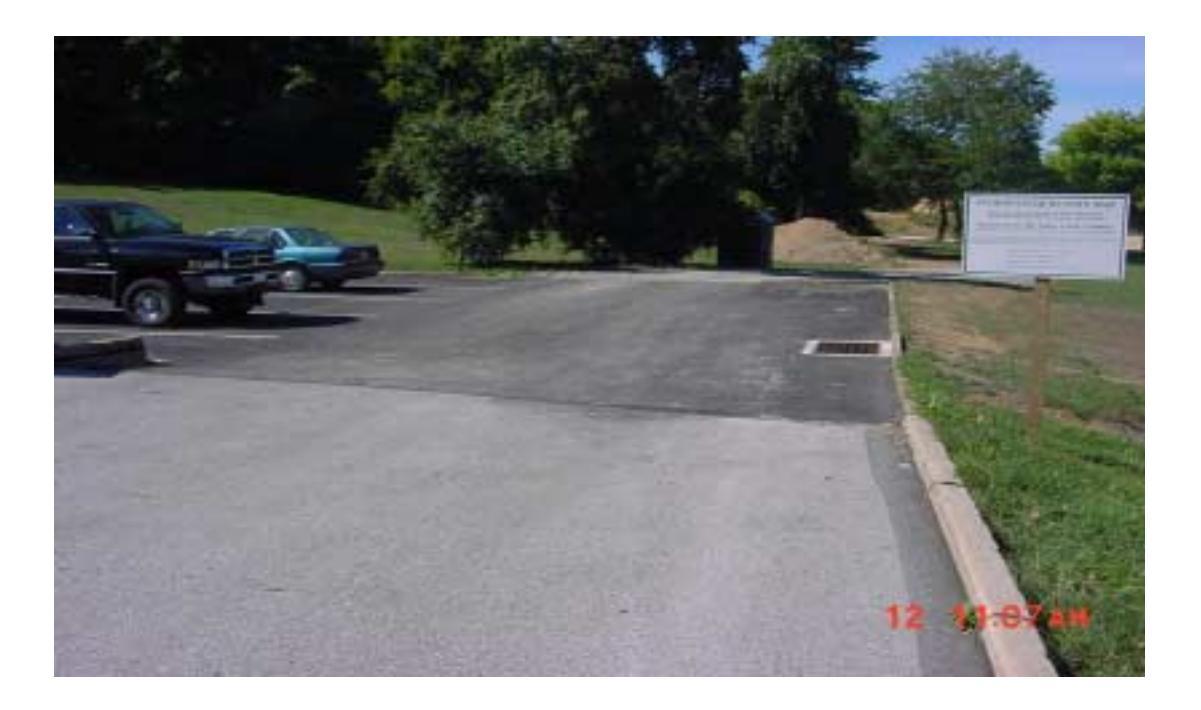
Pictured above and below is the porous pavement lot. Underneath the pavement is a subsurface recharge bed comprised of stone and perforated PVC pipe where stormwater accumulates prior to infiltration into the ground below. Above: the darker lot in the background is paved with porous pavement. Below: the shallow stormwater basin that receives any overflow is located on the other side of the curb.

**Description:** Porous pavement is a permeable surface paving material comprised of bituminous concrete mixtures that permits stormwater to infiltrate down through the pavement's tiny interstitial spaces. Below the porous pavement is a subsurface storage structure called a recharge bed constructed to temporarily store infiltrating stormwater prior its seepage into the underlying ground and water table. This recharge bed stores stormwater in a network of perforated PVC pipes and in the void space of the crushed stone bed that surrounds the piping. The recharge bed is lined with geotextile filter fabric to prevent clogging by small particles. Soils under the recharge bed must remain moderately permeable with depth to permit the infiltration of stormwater into water table and groundwater below. When the recharge bed exceeds its storage capacity stormwater overflows through an outfall pipe into the nearby stormwater basin.
