Bathymetric Map of Chambers Lake at Hibernia County Park, Chester County, PA

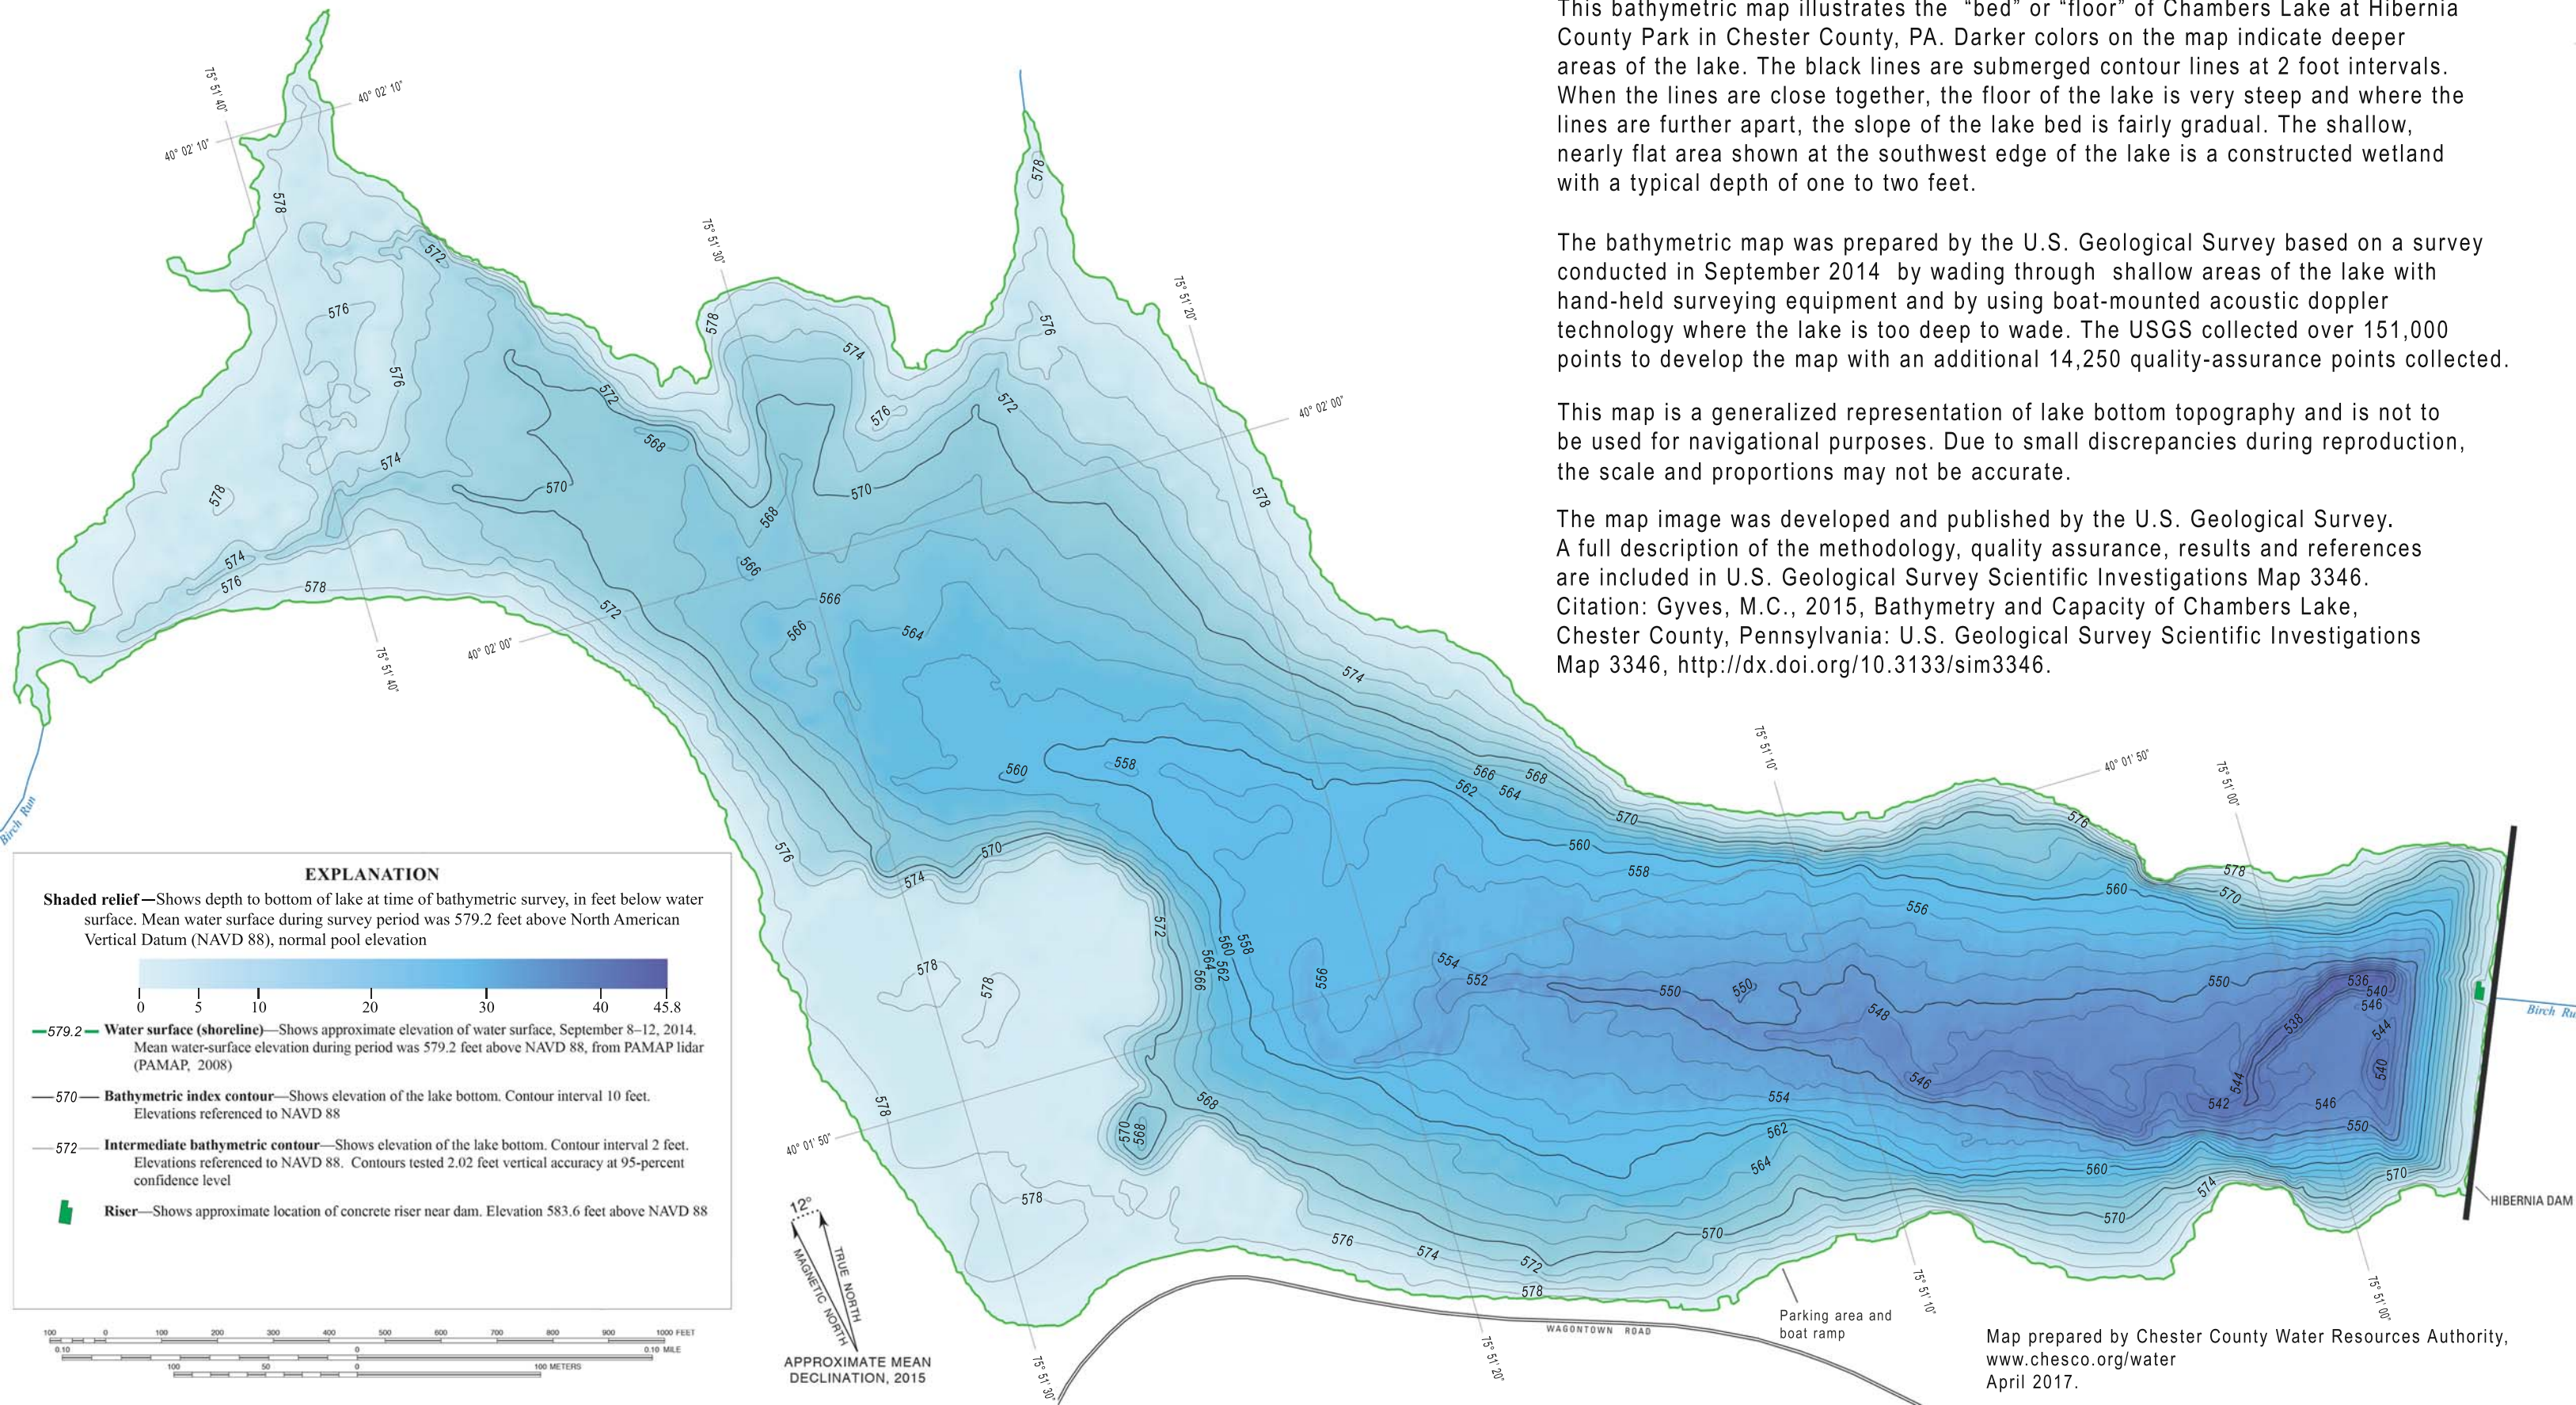
This bathymetric map illustrates the “bed” or “floor” of Chambers Lake at Hibernia County Park in Chester County, PA. Darker colors on the map indicate deeper areas of the lake. The black lines are submerged contour lines at 2 foot intervals. When the lines are close together, the floor of the lake is very steep and where the lines are further apart, the slope of the lake bed is fairly gradual. The shallow, nearly flat area shown at the southwest edge of the lake is a constructed wetland with a typical depth of one to two feet.

The bathymetric map was prepared by the U.S. Geological Survey based on a survey conducted in September 2014 by wading through shallow areas of the lake with hand-held surveying equipment and by using boat-mounted acoustic doppler technology where the lake is too deep to wade. The USGS collected over 151,000 points to develop the map with an additional 14,250 quality-assurance points collected.
