Chester County Stormwater BMP Tour Guide

Published by: Chester County Conservation District

BMP: **Infiltration Trenches (Infiltration Berms)**

Site Name: Hills of Sullivan Residential Subdivision

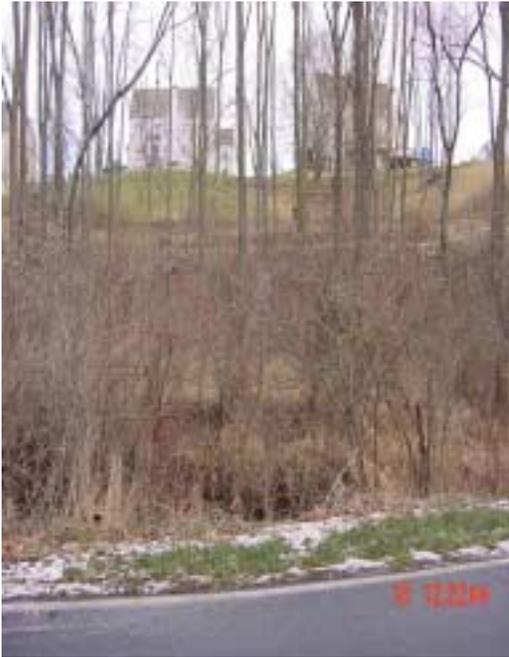
View from Clay Creek Rd: trenches at the base of the grassy hill in background; berms barely visible through trees as horizontal undulations.

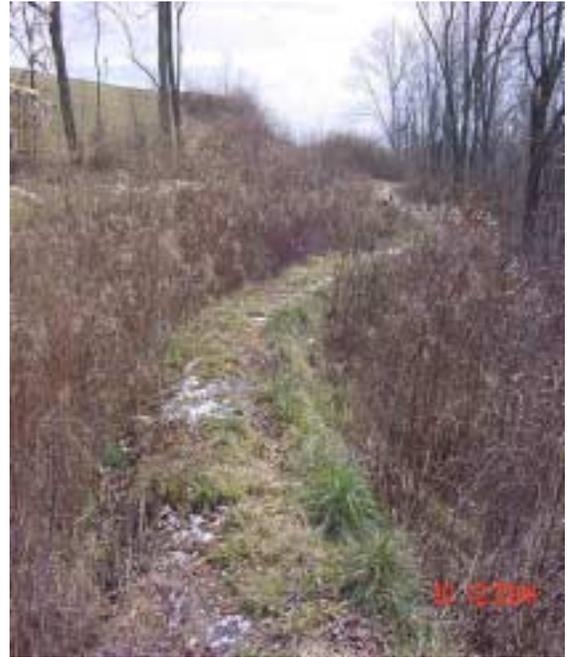
This grassy path is an embankment, or berm, creating depressions for recharge trenches located to the left of the path.

Function: Infiltration trenches replenish the water table, recharge groundwater supplies, and stabilize base flow in streams. They provide efficient recharge since infiltration occurs close to where the runoff is generated thus limiting evaporative loss and infiltrating more rainfall. They provide an opportunity for physical filtration of pollutants in stormwater runoff removing suspended solids including dirt and sand particles (solids accumulate in vegetation and bottom soils). Oil and grease bound to suspended particles, and their heavy metal constituents, may also be filtered from runoff. This structure provides natural vegetated open space for wildlife. The berms of the trenches function as a walking trail for the community and provide maintenance access.

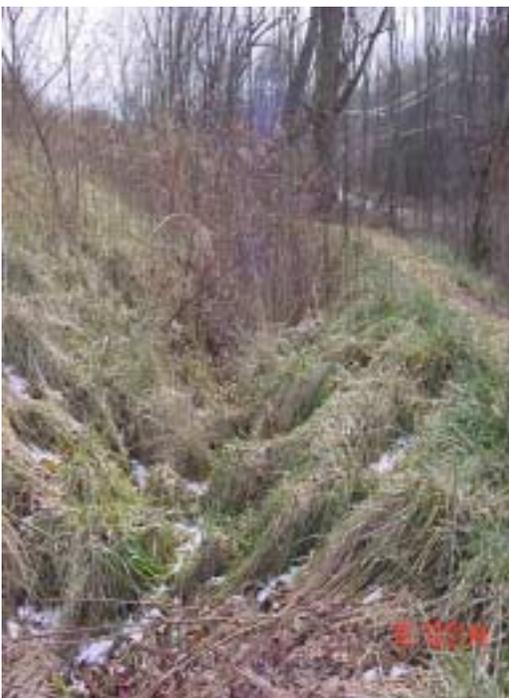
Narrow, vegetated recharge trenches follow land contours and take on a naturalized appearance.

Description: Infiltration trenches, also called infiltrator berms, are narrow, elongated, depressions created by built up earthen embankments, or berms, that promote stormwater infiltration. At this site, the infiltration trenches are elongated, shallow trenches that collect and temporarily store stormwater runoff from the upslope residential lots and streets and promote its infiltration. Stormwater that collects in these narrow depressions on the hillside gradually seeps through the soil into the ground and eventually into the creek and water table below. These berms and their respective trenches run across the slope and follow the contours of the land. There are three 400' long trenches terraced, or stepped, down the slope with one below another. When the uphill trench is filled to capacity, stormwater overflows into the trench below. There is also a single 1000' long trench that functions independently of the three terraced trenches. This large trench receives stormwater through a subsurface pipe. Because stormwater entering this trench is conveyed through a pipe with a steep slope and has high velocity, a concrete chamber is used to dissipate its energy before discharging into the trench. When this trench overflows, stormwater spills over its downslope berm and flows down the bank into the stream below.

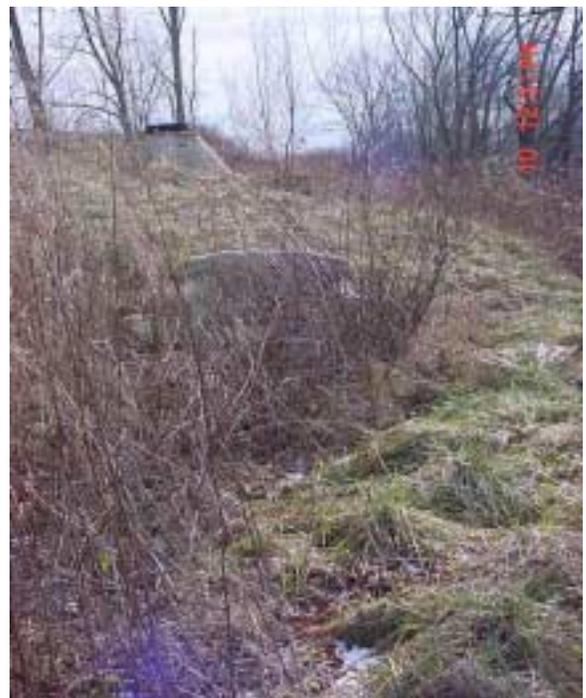
This trench has a subsurface energy dissipator to reduce the velocity of entering stormwater.

- Regularly inspect to ensure they are infiltrating
- Regularly inspect structural components (i.e. energy dissipater, inlet structure) to ensure they are functioning properly
- Periodically clip plants to ensure their growth does not impede the flow of water through the structure
- Remove invasive plants as necessary (remove shoots and roots)
- Routinely remove accumulated trash and debris
- Avoid running heavy equipment in the trenches to prevent soil compaction
- At the completion of construction, scrape soils to remove accumulated sediment and conduct soil percolation test
- Do not apply chemical pesticides or fertilizers to turf in and around infiltration structures
