Chester County Stormwater BMP Tour Guide

Published by: Chester County Conservation District

BMP:	Rain Garden and Wet Pond
Site Name:	Pocopson Township Public Works Depot
Location:	Pocopson Township, ADC Map Coordinates: 40-F7 <i>Directions: Route 52 4-6 miles south of Brandywine Creek</i>
Watershed:	Brandywine Creek (Stream Designation: TSF, MF)
Land Use:	Light Industrial

Site 17 - Pocopson Public Works Depot – Rain Garden

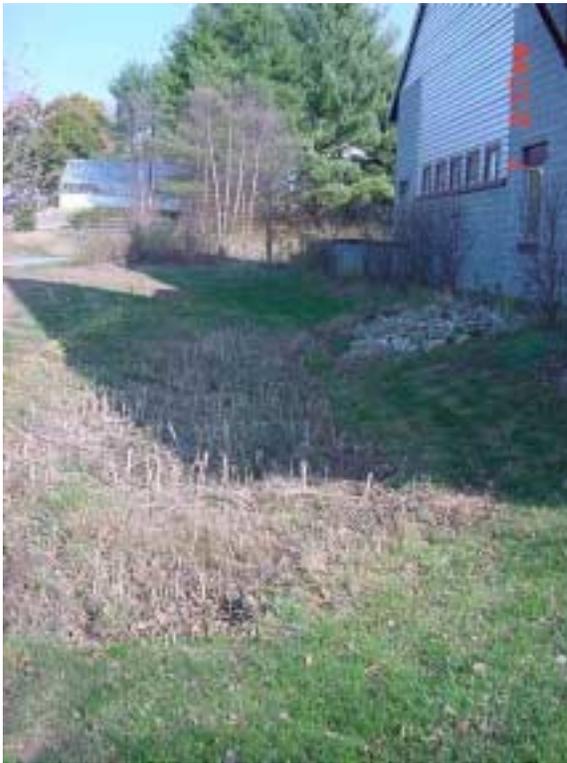
Vegetation in the Rain Garden (upper left) was cut back in the fall; rip rap bank along building receives runoff flowing directly off the roof. **Upper right:** downspout directs runoff into a grass-lined channel around cinder block wall. **Below:** Wetland vegetation thriving in and around wet pond pictured below.

Description: A **rain garden** is a shallow earthen stormwater basin planted with native vegetation that infiltrates accumulated stormwater. The rain garden receives overland flow from parking areas, vehicle wash areas, and from the roof. Roof runoff flows off a roof ledge and directly into a stone embankment into the rain garden. Vegetation planted in the structure must tolerate variable soil moisture conditions, including periodic inundation of stormwater following storm events and standing water. Soils in this structure must remain uncompacted and permeable to ensure stormwater infiltration into the subsurface.
